**FRACTURE CONDUCTIVITY OF A BAUXITE-PROPPED
GEOTHERMAL SYSTEM**

A thesis submitted to the faculty of
The University of Utah
in partial fulfillment of the requirements for the degree of

Department of Chemical Engineering

December 2013

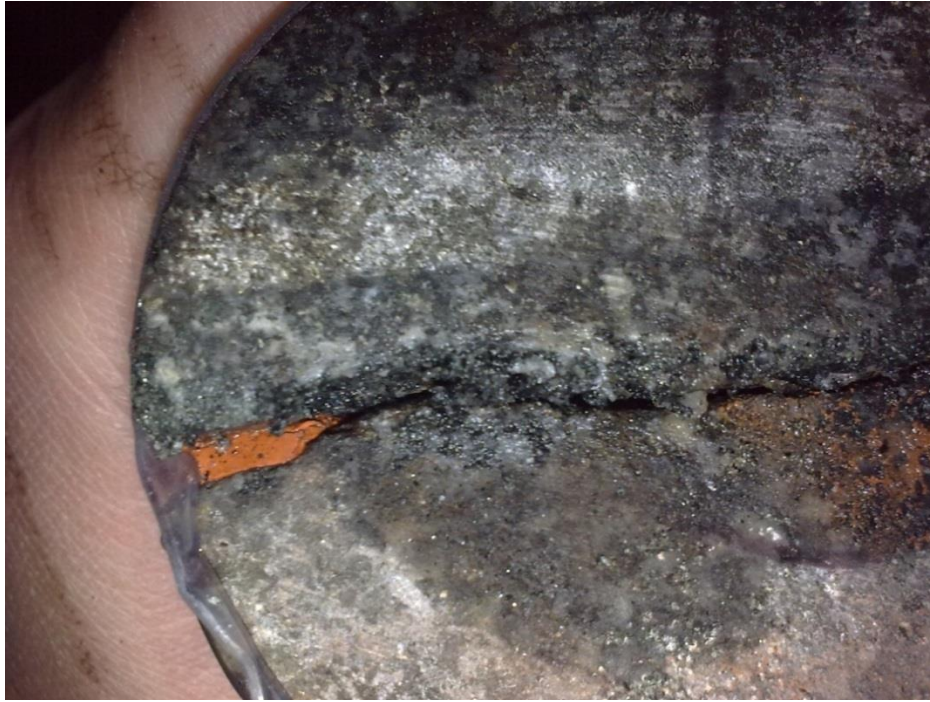
Figure 6.3. This is a view of the outlet of the fracture- after testing of a proppant-free, translated fracture – tested to simulate what has been alleged to result as shear-induced self-propping due to asperity override at low normal stress. The orange strip is a flexible membrane installed along saw cut grooves (sawn to guide the fracture when the sample was mechanically split).

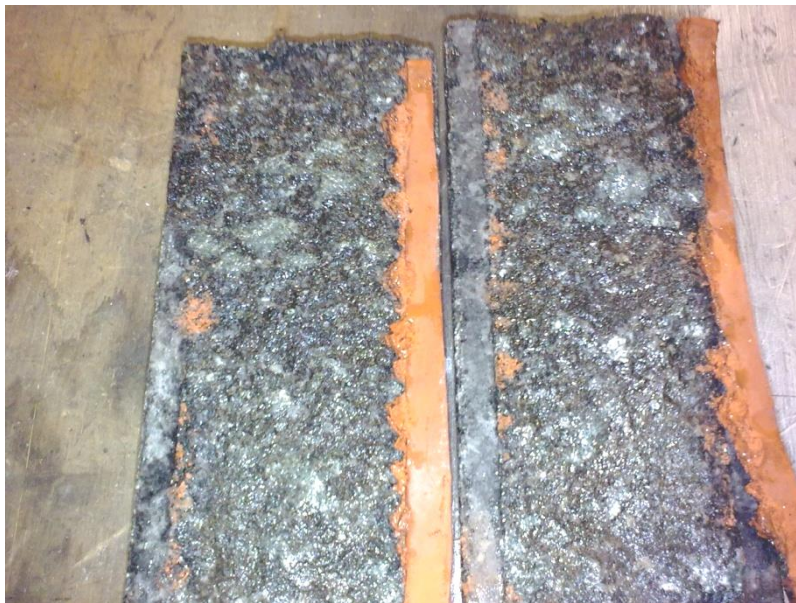
In Figure 6.4, the sample had been opened up (still with the offset) and photographed. The majority of fracture surface in the figure is covered with wetted granite grains. After initial observations of the fracture faces, the granite debris was removed. Figure 6.5 shows the fracture faces with most of the granite fines removed by gentle sweeping. It is apparent that the surface of the “sheared” fracture had been degraded after only five days of exposure to stress and moderate temperature. Based on conductivity measurements, it appears that most of the conductivity loss occurred at the increased normal stress – at a value which is easily within the effective normal stress range that would be experienced in current geothermal operations.

Figure 6.4. Granite fines – caused by fracture face degradation – are visible on the fracture surface (all dark areas encompassing nearly the entire fracture surface area). The sample has been removed from its jacket and rotated open.

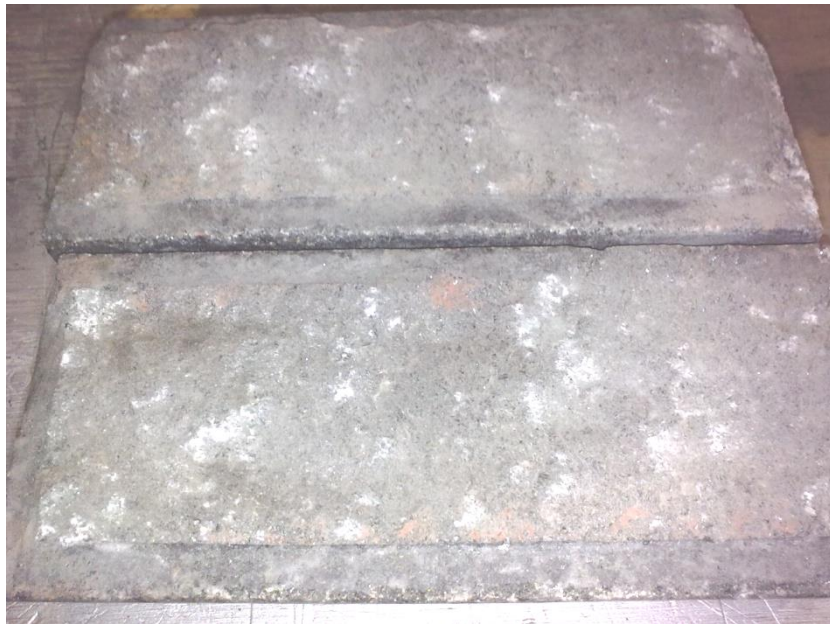
Figure 6.5. Proppantless fracture after granite fines were removed, posttesting. Comparing the fracture face above to another similarly wedge-split sample by touch indicated that most of the bridging asperities during testing were fractured, creating the granite fines in the fracture that diminished conductivity.

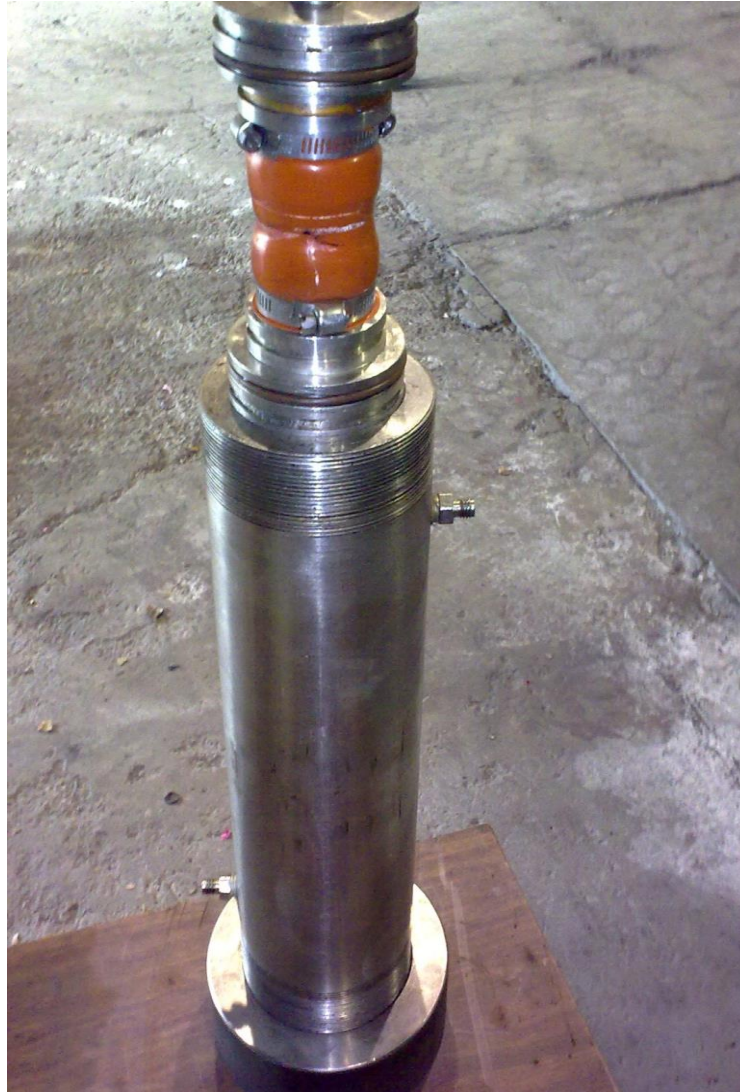
Figure A.1. Small Vessel System.

The orange silicon tape was used on the extruded portion in contact with the rock of the endcap to help seal the ends of the Teflon jacket securing the rock from the confining fluid. Although an o-ring was placed in a groove under the silicon tape (about

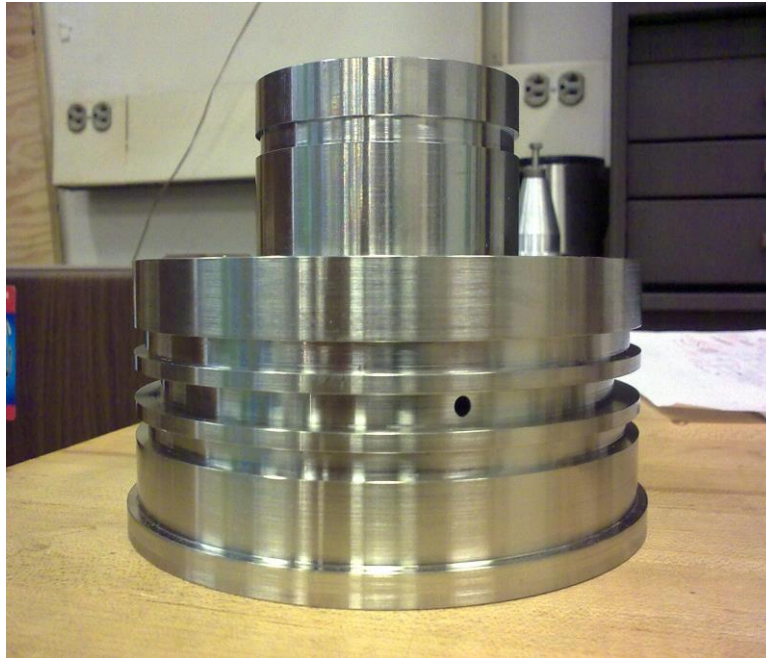
The groove on the protruding portion of the endcap is a tape groove, which is used instead of an o-ring groove. Silicon tape is placed in the groove and after the sample has been jacketed to the endcaps, tie wire is wrapped around the jacket and pinches it into the silicon tape, sealing the jacket from confining fluid. Figure A.4 is a machine drawing of the endcaps. It shows the grooves on the faceplate. These grooves were similar to features in the smaller-diameter vessel. The two concentric circular grooves were connected by radial grooves. This ensured that

Figure A.3. Endcap, o-ring and cooling grooves

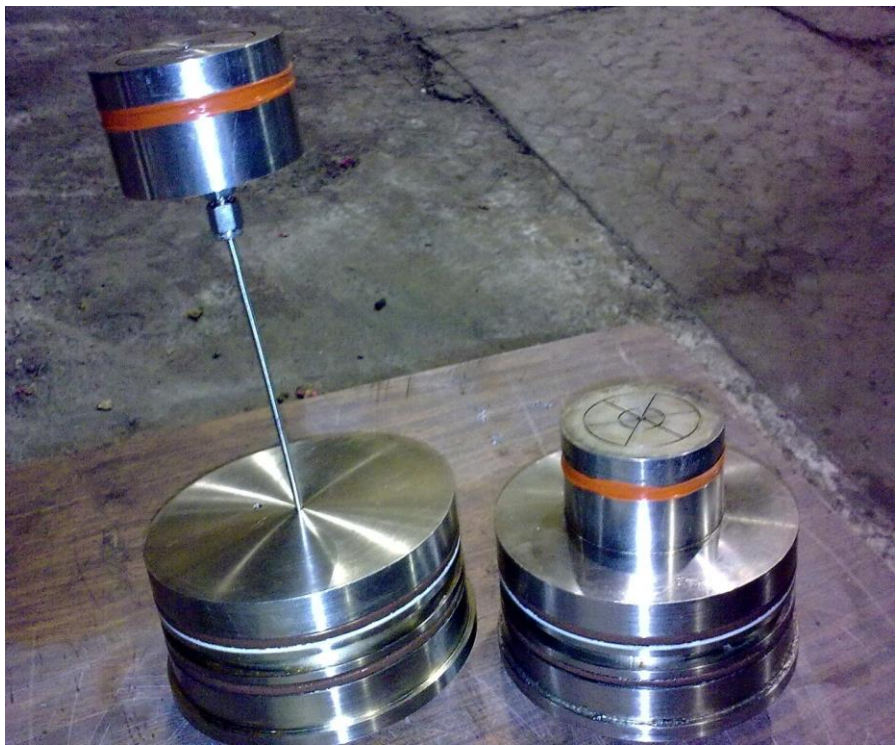
Figure A.5. Stationary and Floating Endcap in the Large Vessel Assembly

As shown in Figure A.5, the tape grooves were filled with silicon tape to seal the sample off from the confining fluid. After the sample was jacketed, tie wire was wrapped around those grooves. Tubing connected through the flow through portion of the endcaps was connected to a differential pressure transducer. Additional images of the endcap and floating endcap piece are shown in Figure A.6 through Figure A.8. The set up of both endcaps with a sample is presented in Figure A.8.

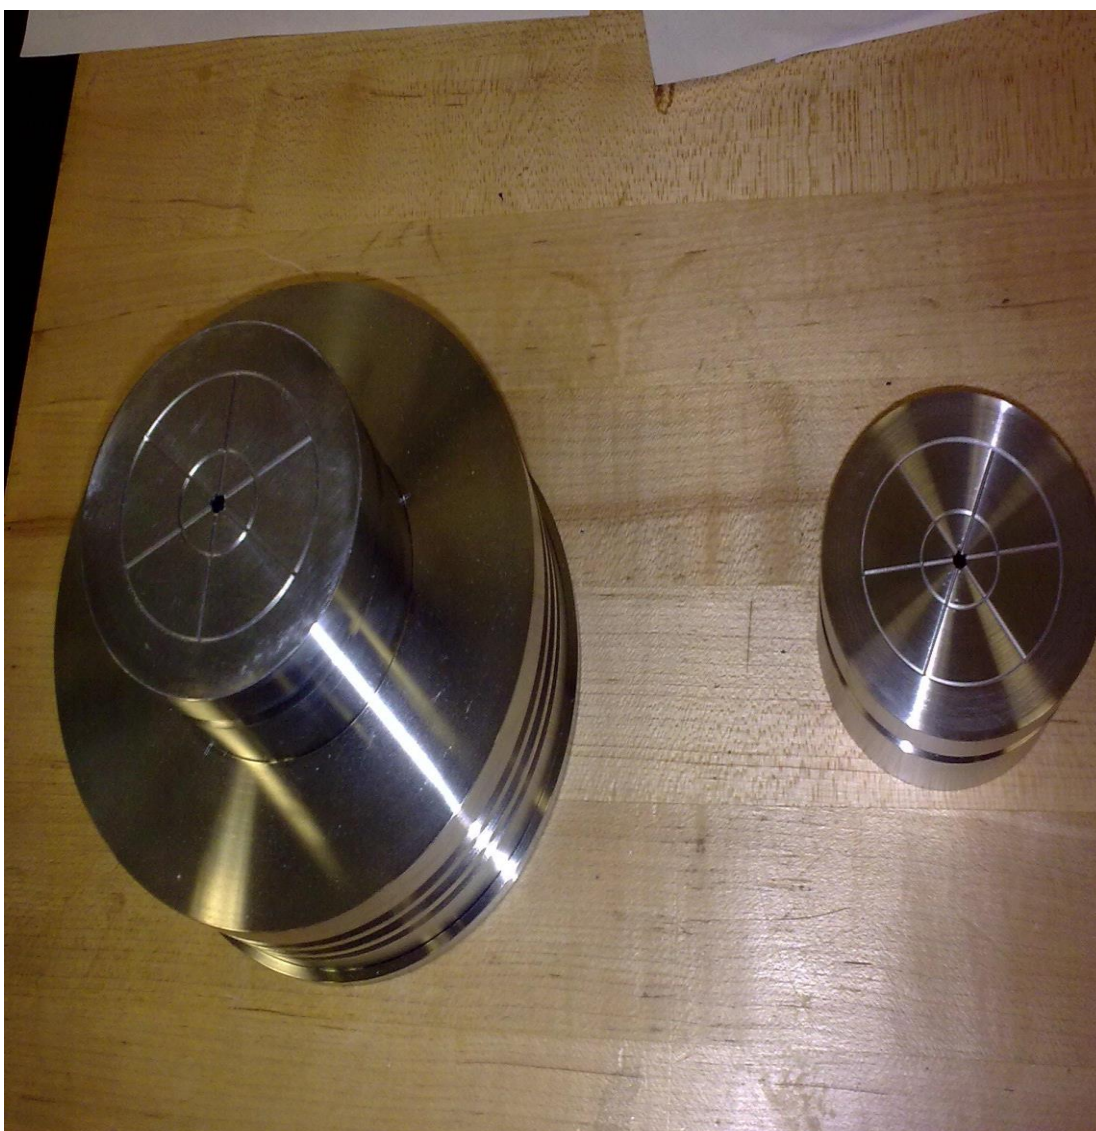
Figure A.6. Endcap with floating endcap piece.

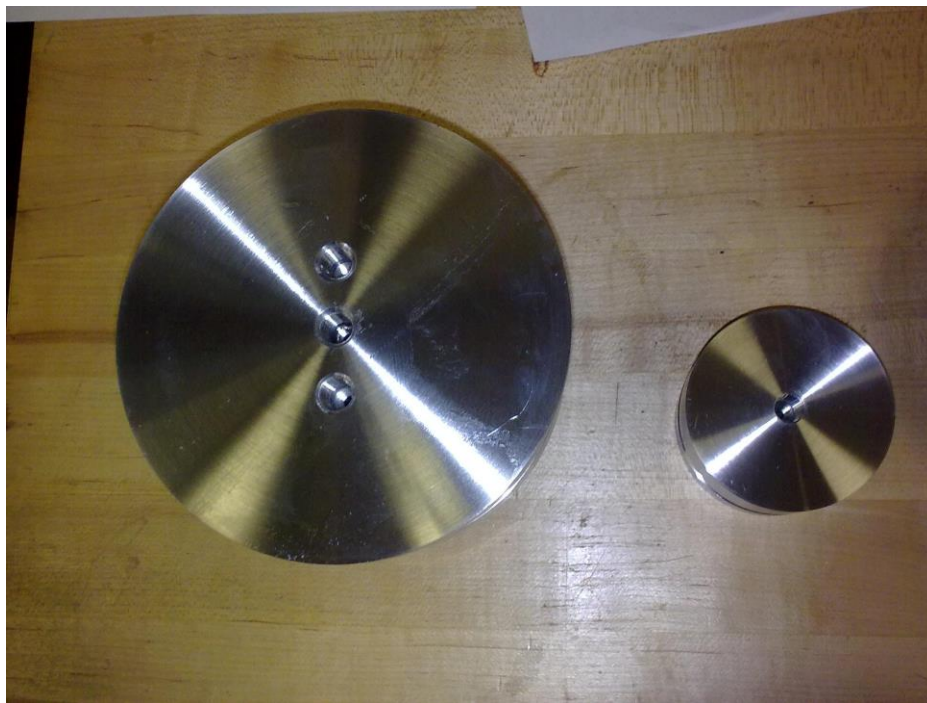
Figure A.7. Back of the Endcaps, all holes are tapped for 1/8" NPT fittings

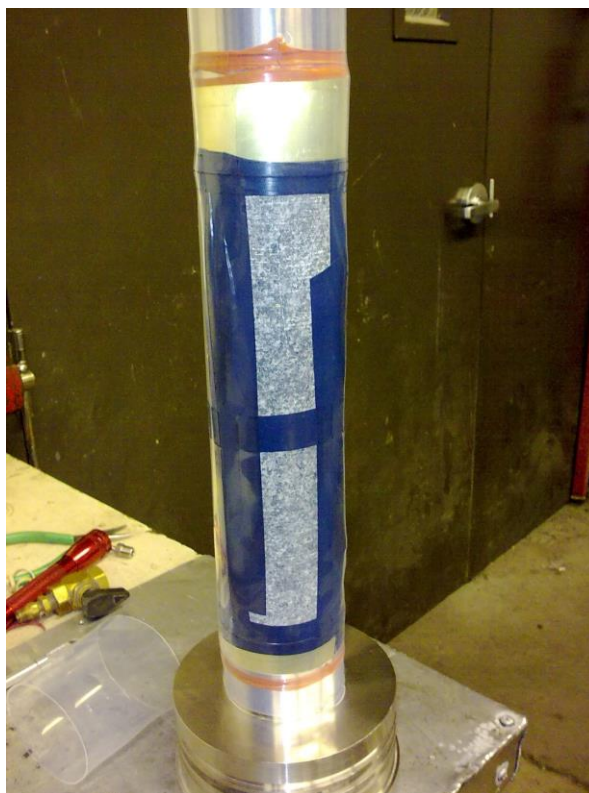
Figure A.8. Inside the vessel

Brass shim stock was used at the rock-endcap interface to prevent failure of the jacket at those points. The blue tape shown on the rock sample was used to similarly hold strips of brass shim stock in place along the sides of the fracture to prevent the confining stress from puncturing the jacket along the length of the propped fracture. After this sample preparation, tie-wire was wrapped around the jacket on top of the tape grooves, as covered by orange silicone tape in Figure A.8. Once the jacket had been wired on, the entire fixture (end caps, proppant sandwiched within granite half cores, jacketing, and tie wires) was placed in the pressure vessel and contained using the sealing end closures. Figure A.9 shows the machining diagram that the core sample was placed in for testing.
